SALT IN THE SOIL

**Prof. R.B. Mapa, Dr. W.M.A.D.B. Wickramasinghe, D.N. Sirisena and
K.M.A. Kendaragama**

Soil Science Society of Sri Lanka

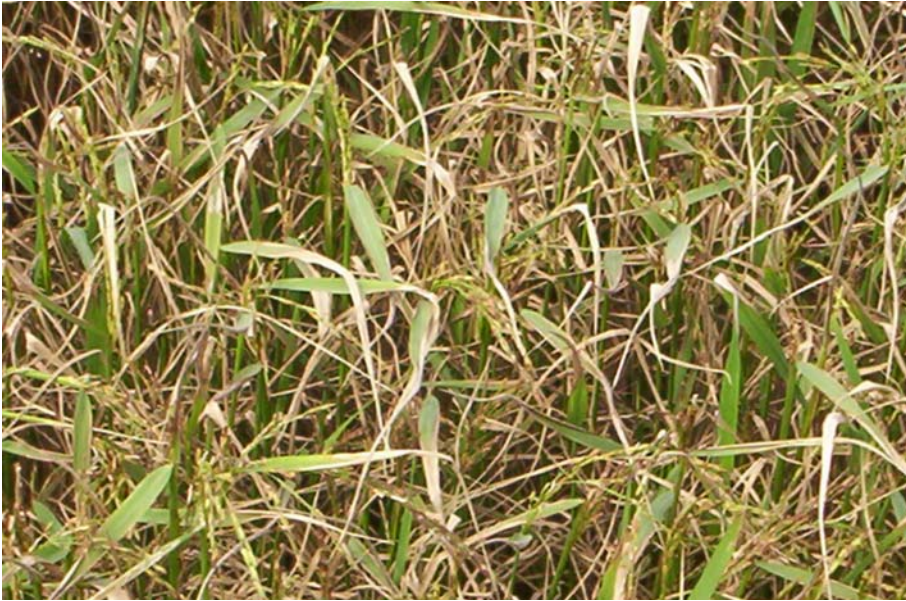
The pictures show affected paddy fields in Nindavur area. About 575 acres of paddy fields were affected in this area where the soil type is Alluvial (Entisols). The rice variety cultivated in most fields was variety BG 94-1 and the crop was totally damaged due to salinity in affected areas. As the crop was near maturity age, grains have become empty. The limit where the crop was visually affected is the limit of seawater intrusion due to tsunami. The electrical conductivity values (EC) of the saturated soil paste indicating the salinity levels in unaffected lands were around 0.04 decisemens per meter (dS/m). In the affected lands, the EC increased to a range of about 20 to 200 times. Highest EC values as 6.2 dS/m were recorded in fields nearest to the sea. The pH of non-affected fields showed a value of 6.4 while in affected fields it increased to only 7.1 showing that the affected lands are saline.

Rice plants affected due to salinity

Short term, medium term and long term strategies are proposed for rehabilitating these lands affected by salinity. The best short-term strategies for paddy lands are to immediately drain them before the salts get more concentrated due to evaporation. For this purpose the drainage channels should be cleaned. The sand and other debris should be removed from the paddy fields and seed

paddy of salt tolerant varieties as At 353, AT 354 and At 401 must be collected immediately, even by offering high prices to farmers already growing these, to be distributed in the next season. Where ever clean water can be used to leach the salts, soil amendments as Gypsum could be used with the supervision of Soil Scientists to make the reclamation faster. Therefore, orders must be placed soon for the Gypsum requirement so it will be available when needed.

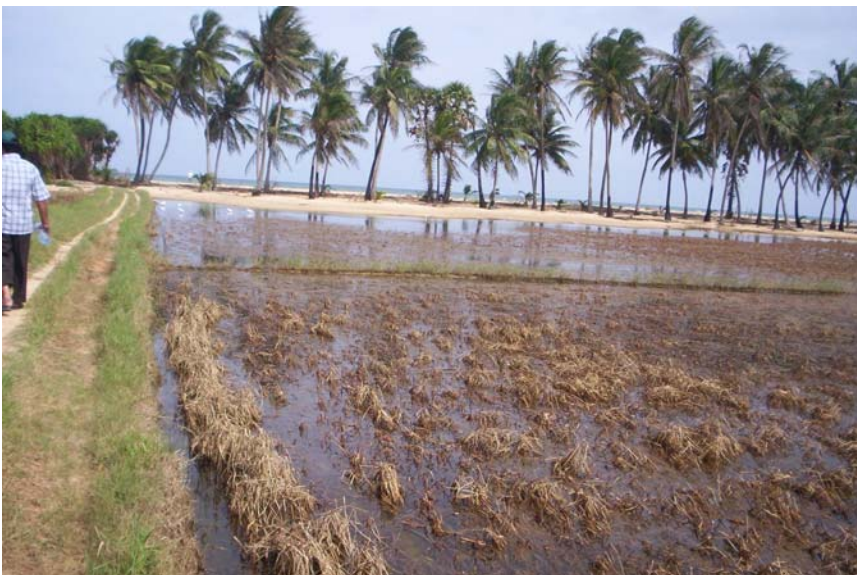
According to the literature, if the EC value is higher than 4 ds/m the crop will be damaged permanently. Some traditional rice varieties tolerant to salinity can be grown up to EC values of 6 to 8 dS/m., but most of the modern varieties except At 354 and At 401 cannot be grown beyond a salinity level of 3 to 3 dS/m. Even at EC levels of 2 dS/m in the saturated paste, the EC near the roots may be higher and the susceptible crops will be affected in numerous ways. The standing water in paddy fields showed EC values of 5.8 to 11.5 dS/m. These results indicated that even after 2 weeks of the tsunami disaster, and after heavy rains, salinity still remains at higher values. As the seepage of water from paddy fields are poor due to the hard pan below the plough depth and as the drainage channels are blocked there is no way for the salts to be washed away. With continuing Evaporation there is a tendency for the salinity levels to become more damaging.

Saline water still remaining in paddy fields

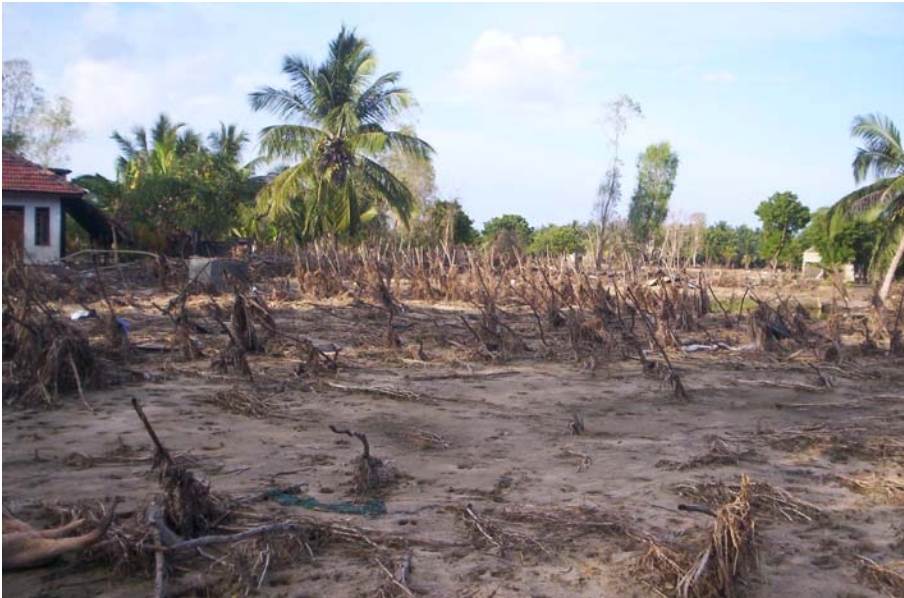
The Vinayagapuram village, where the highlands were examined consisted of about 460 acres of tomato, brinjals, chillies, maize and cowpea. These annuals as well as perennials as banana and even Palmyra palms were damaged due to the sea waves and salinity. The soils of this area belong to sandy Regosols (*****) and the water has already drained away. Due to the heavy rains after the tsunami disaster and the well-drained conditions, the salts have got washed off in these highlands. Therefore, the EC of soils in well-drained areas were in the range of 0.13 to 0.60 dS/m. In areas where soil was eroded due to the force of the waves, pools of stagnant water could be observed. The EC of this stagnant water was high as 3 dS/m which is highly damaging to many crops. In some of these areas where water had evaporated, patches of salt crust could be seen on the land surface.

Due to the high amount of Sodium, the soil structure is broken down (get dispersed) and these lands will be very susceptible to erosion. The well water in highlands showed high EC values of 3 dS/m and water table was near to the soil surface. This well water cannot be used for any domestic or agricultural purpose. The shallow ground water table will contribute to increase in salinity with time. The evaporation rates are high as 6 to 8 mm/day in the *yala* season which will worsen this situation.

Tomato crop affected by tsunami

The short-term measures for rehabilitating highlands include removing sand and other debris from the lands and improving the drainage by construction of drains to lower the water table. The wells have to be emptied, cleaned and rehabilitated so that no more salt water will enter the subsoil. Once the wells are cleaned they could be used for domestic purposes and irrigation. Removing the excess water from eroded depressions must be done as soon as possible. Programs have to be initiated to distribute planting material of salt tolerant crops for home gardens. The medium term measures should be to educate the farmers about special agricultural practices to

reduce salinity, providing agricultural implements and salt tolerant varieties and monitor the salinity levels by field officers. Conductivity meters for measuring salinity should be provided for the extension officers of these areas and training provided in time.

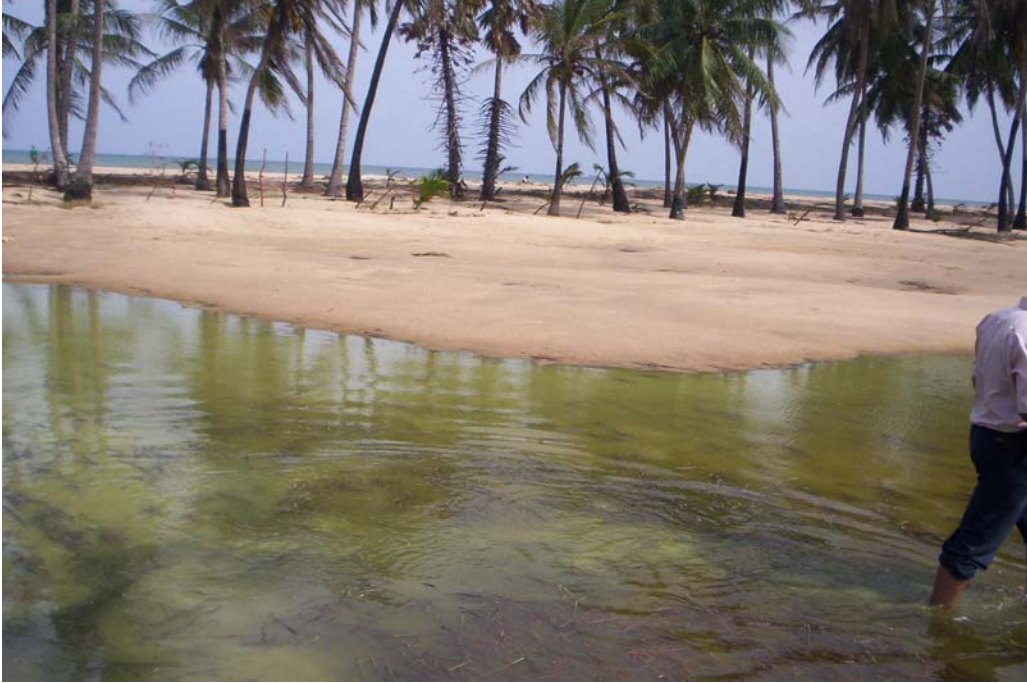
Areas as these need to be drained as soon as possible
